Site Specific Details:

This intersection has poor sight distance greatly attributed to rolling vertical grade along the east and west bound Route 11 roadway corridors. The intersection currently has under 500 ft. of site distance for west bound entry and is located in the taper of an existing turning lane. The intersection needs to be formally evaluated to improve the safety when exiting Novell Road and entering Route 11.

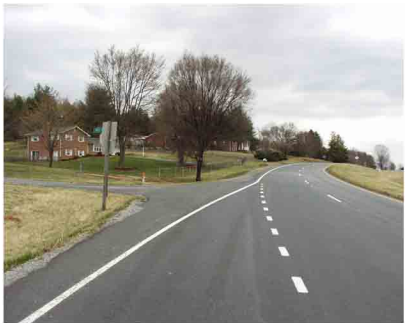
Field photo of existing intersection of Novell Road and Route 11. View of photo is to the east from center of west bound turn lane.

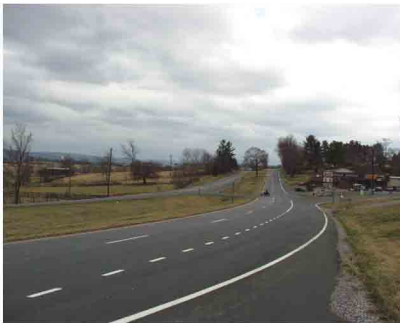
Field photo of existing intersection of Novell Road and Route 11. View of photo is to west from the center of Novell Road Exit Lane.

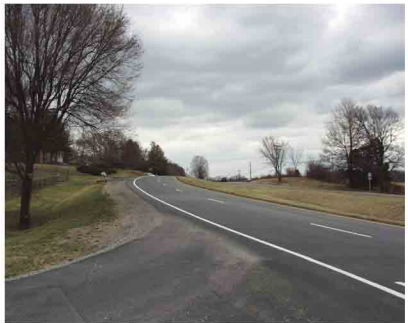
Field photo of existing intersection of Hatcher Road and Route 11. View of photo is to the east from the center of Novell Road exit lane.
